# Crystal Fire® Plus: Complete Troubleshooting Guide

For Crystal Fire® Plus burners that are exhibiting nuisance shutdowns, please follow this troubleshooting guide. A nuisance shutdown can be defined as any shutdown that is not initiated by the user. This can occur immediately upon startup or after approximately 20-30 minutes.

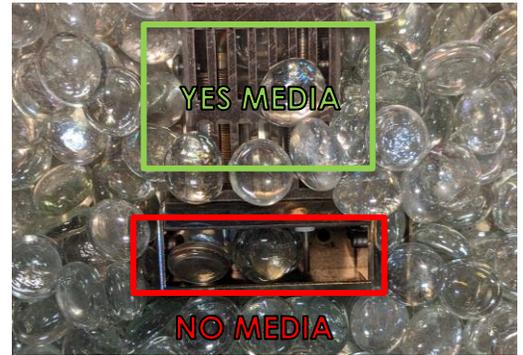
Image 1

1. When lighting the burner, ensure that the control knob is being fully depressed until it cannot move further. Partial engagement of the internal components due to a partially depressed knob can cause nuisance shutdowns.
2. Ensure that there is no media within the wind guard. See Image 1. If there is media present inside the wind guard, carefully remove it from the wind guard opening. Media can be present on the back cover of the wind guard.
3. Verify which version of the wind guard is installed on the burner. See Image 2.

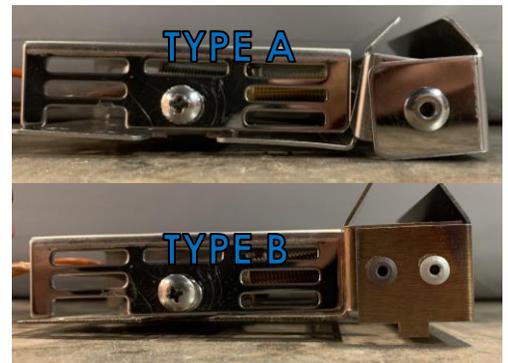
Image 2

If wind guard has one rivet on each side (Type A), continue with Step 3a. If wind guard has two rivets on each side (Type B), continue to Step 4.

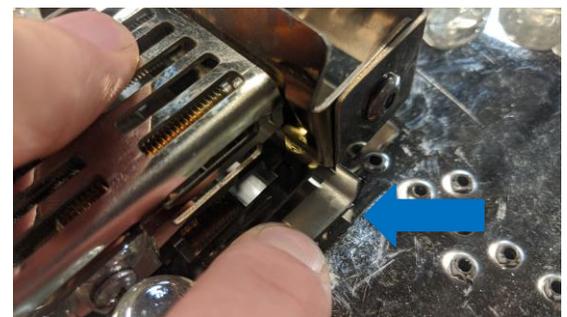
Image 3

- a. Is there a sheet metal riser clip installed under the wind guard? See Image 3. If yes, continue to Step 3b. If no, one must be sent out and installed. (P/N: 10316)
- b. Ensure that the clip is not covering any ports on the burner surface.
- c. Verify that the wind guard components are properly aligned to allow for a small gap at the front of the wind guard (~1/8"– 3/16"). See Image 4.

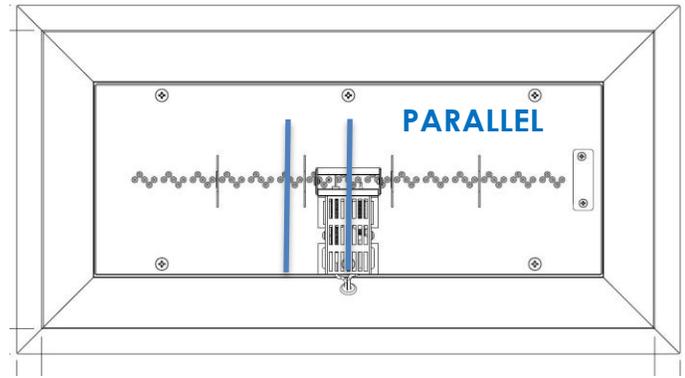
Image 5

4. Verify that wind guard is properly positioned on burner surface. Wind guard assembly should be parallel to wind fins on linear burners. See Image 5.
5. Check the entire length of the thermocouple for severe kinks or breakage. See Image 6. If damage has occurred to the thermocouple, a replacement assembly must be sent out. (P/N: VCSV-WG)
6. Ensure that the thermocouple is properly tightened. A properly tightened thermocouple will have one thread exposed from the body of the control valve. See Image 7.
7. Verify that thermocouple is not contacting the wind guard in any location. The tip of the thermocouple should be centered in the hole of the wind guard. See Image 8.

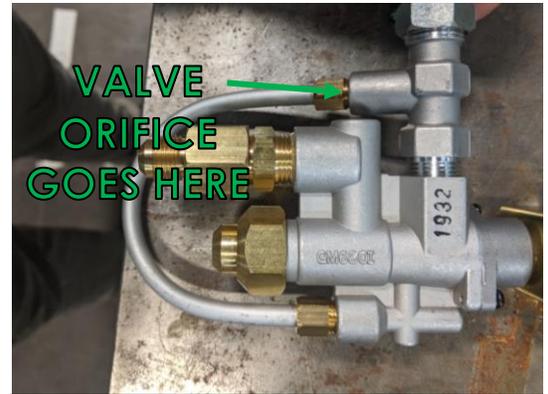
Image 9

8. Ensure burner is operating on the correct fuel type. Burners are set up standard for LP gas operation. Conversion to natural gas operation requires both the valve and burner orifice to change as well as closing the air shutter. See Image 9.
9. If Steps 1-7 have been completed and burner still shuts down after 20-30 minutes, check the outer surface of the LP tank after the burner shuts down. If there is frost on the tank, the overfill protection device of the tank has likely activated and caused the shutdown. See Image 10. This issue would be especially applicable to CFP1242 and CFP30 burners, which are larger burners.

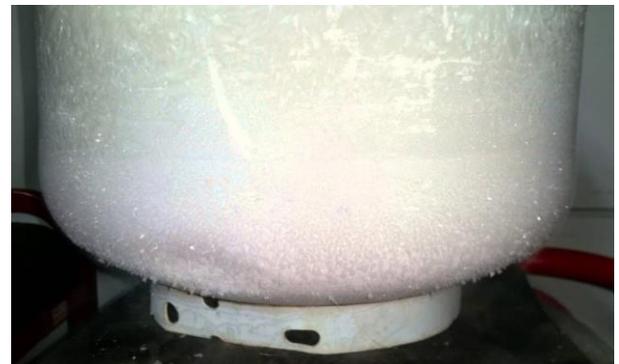
Image 10

This can be verified by listening to control valve. If the flame goes out and is followed by an audible click at the valve, this means that the LP tank caused the shutdown. If the flame goes out at the exact same time as the click at the valve, the system is still not receiving an adequate signal from the thermocouple. Follow the link or QR code below for a video demonstrating the "click".
